# INSTALLATION INSTRUCTIONS

204016/204016-2

## 3" SIDEBAR WITH BENT END

04-10 CHEVY COLORADO/ GMC CANYON CREW CAB

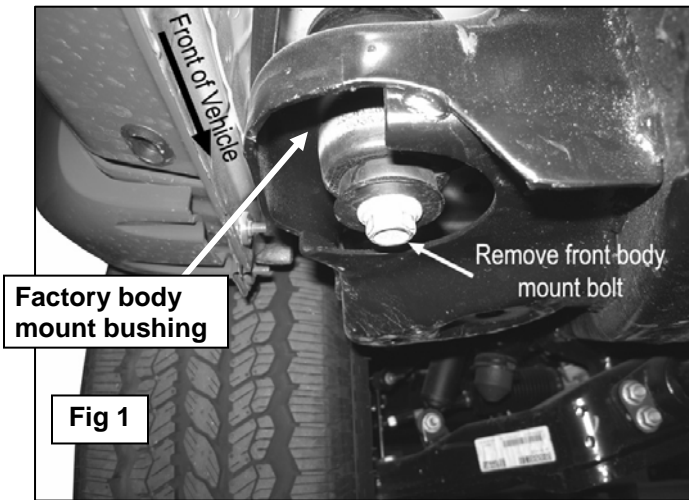
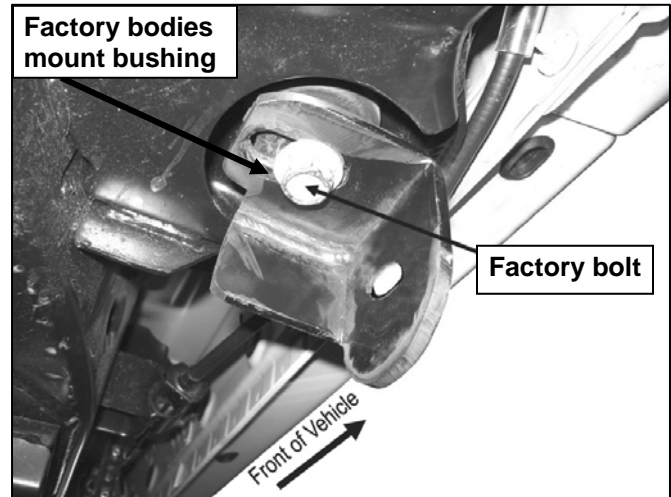
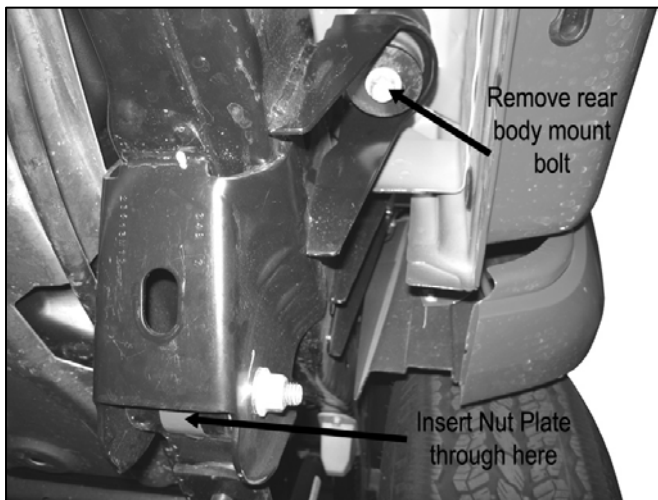
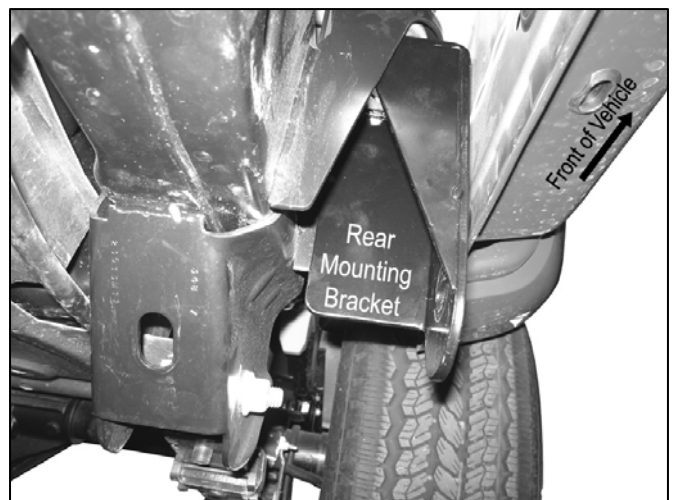
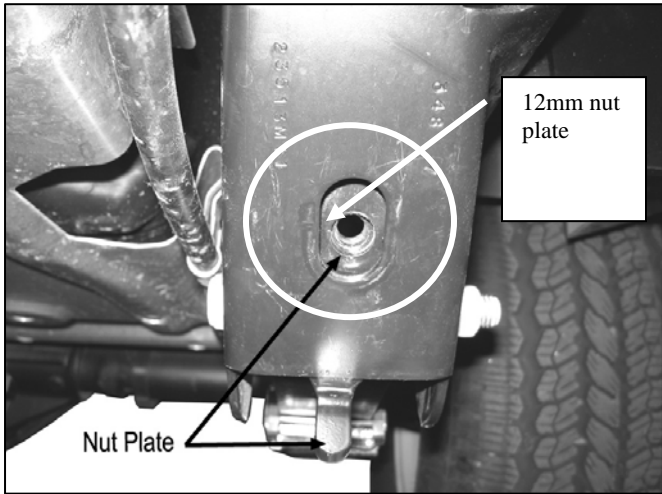
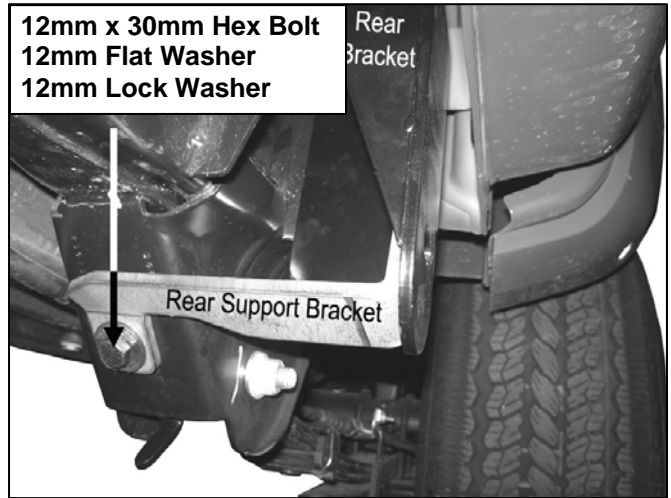
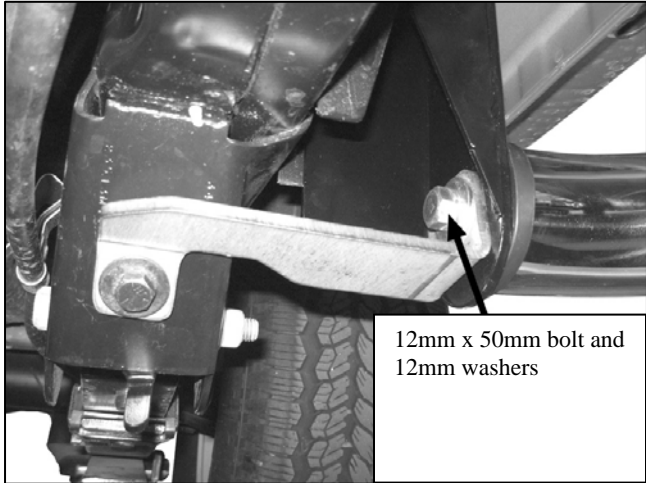
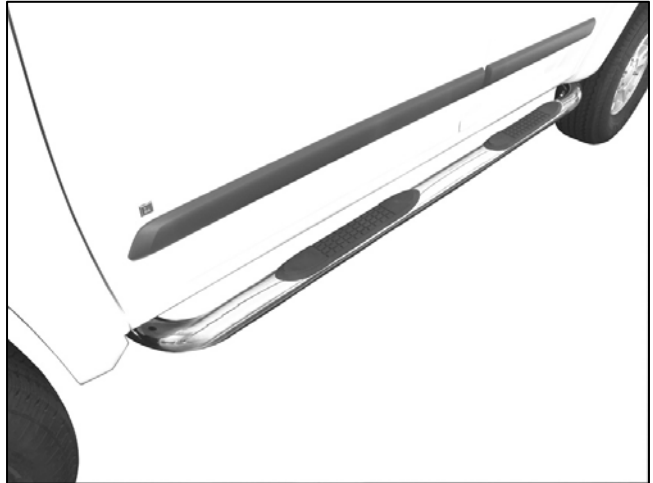
### Driver Side Installation Pictured

1. REMOVE CONTENTS FROM BOX. VERIFY ALL PARTS ARE PRESENT. READ INSTRUCTIONS CAREFULLY BEFORE STARTING INSTALLATION.
2. Starting on the driver side, remove the factory front body mount bolt from the underside of the cab, **(Figure 1)**. **NOTE:** The factory body mount bolts need to be driven out of and back into the steel washer molded into the rubber bushing. Take precautions to avoid damage to the threads or the washer and bushing, **(Figure 2)**.

3. Locate the driver side front Mounting Bracket and bolt it to the vehicle using the factory body mount bolt, **NOTE:** Brackets mount over bushings.
4. Locate the driver side rear Mounting Bracket and bolt it to the vehicle using the factory body mount bolts. **NOTE:** Brackets mount over bushings.

5. Insert one of the 12mm Nut Plates through the bottom of the front face of the leaf spring mounting bracket and align it to the factory oval hole.
6. With the 90-degree bend towards the side of the vehicle and facing up, partially attach the driver side Support Bracket to the already inserted Nut Plate using the included (1) 12mm x 30mm Hex Head Bolt, (1) 12mm Lock Washer and (1) 12mm Flat Washer **NOTE:** The 90-degree bent end of the Support Bracket should line up with the hole in the rear Mounting Bracket. Snug but do not tighten hardware at this time.

7. Carefully position the driver Sidebar up to the Mounting Brackets. Line up the mounting hole in the Front Support Bracket with the hole in the Front Mounting Bracket, **(Figure 9)**. Use the included (2) 12mm x 50 Hex Head Bolts, (2) 12mm Lock Washers, and (2) 12mm Flat Washers to attach the Sidebar to the Mounting Brackets
