B & V PRODUCTS 2015-20 FORD F150/ 2014-20 RAPTOR/
 2017-20 F250/ F350 SUPERDUTY CONSOLE SAFE HALF OPEN
 SECTION w/ TRAY
 PART # 7045-1000-17
www.bvnproducts.com

**TOOLS REQUIRED** 11mm, 10mm & 7mm sockets and ratchet, cordless drill, 1/4" & 3/8" drillbits and a large pry bar. 10.2.23

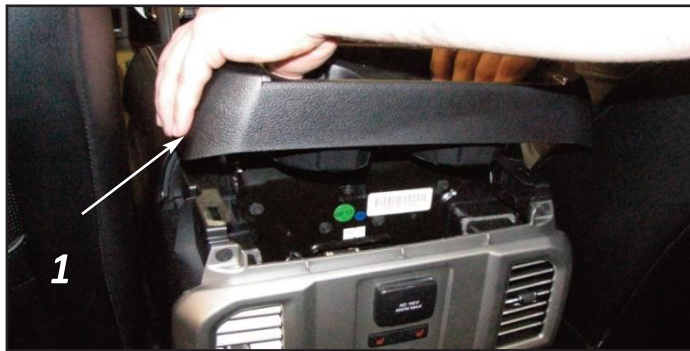
← Important:
 This console safe will not fit models without the factory "full length" center console.

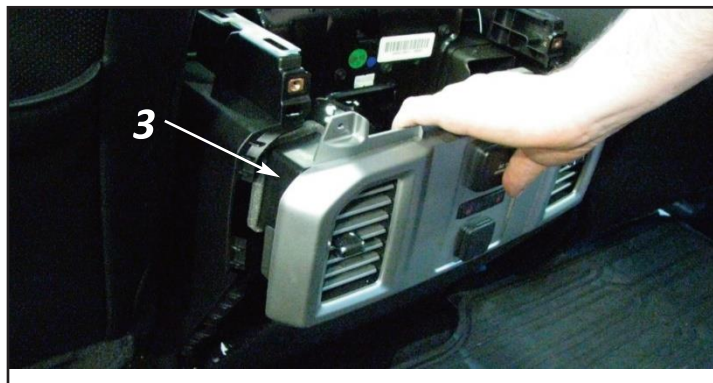
2. Once the cup holder section is out of the way, remove the two upper 7mm hex head screws (one each side) retaining the rear portion of the console.

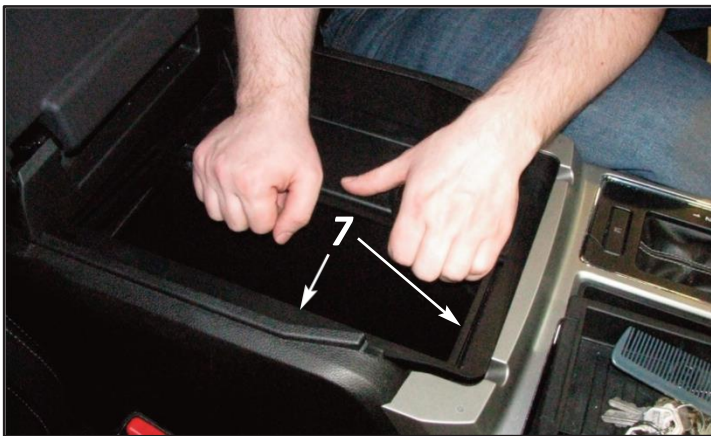
6. Make sure the console is empty and the lower liner has been removed. Carefully align the console safe into the console opening, tilting the front of the vault slightly down **(A)** and the bottom **(B)** towards the passenger side of the vehicle.

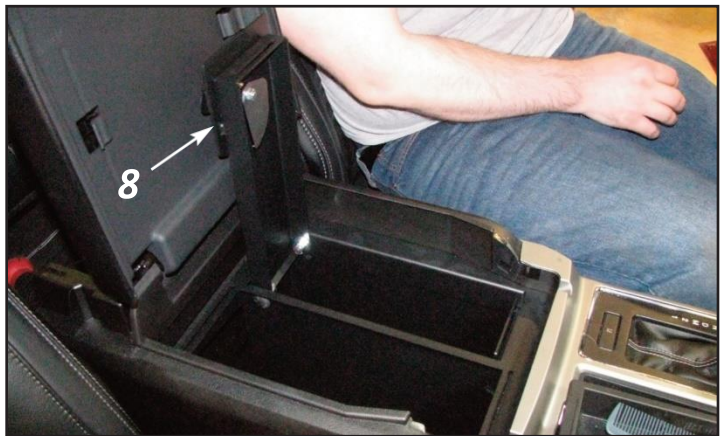
7. Finish rotating the console safe down into position until the top of the vault is resting against the inner ledge.

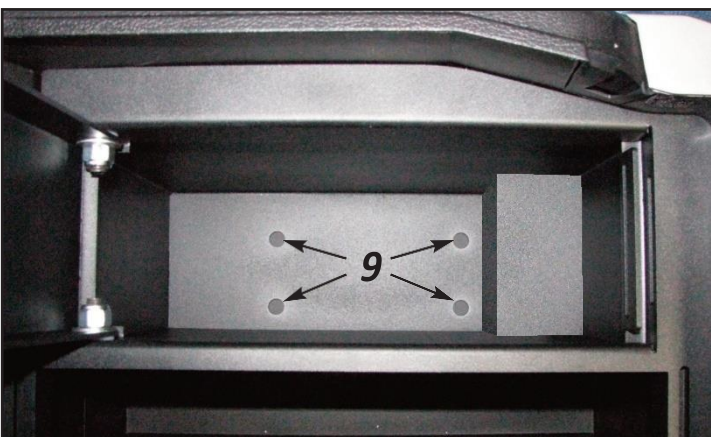
8. Once the console safe is in position, open the door to access the lower mounting holes for the following hole drilling procedure.

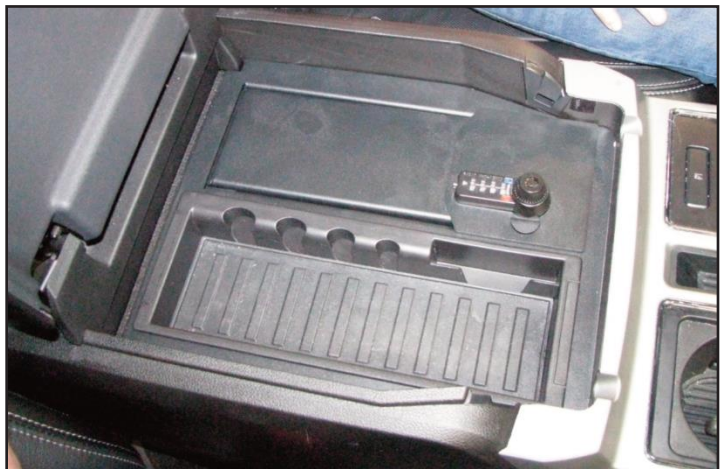
13. Once the stainless steel cage nuts on the lower mounting bracket align with the holes enlarged in **Step 11**, install the supplied 1/4-20 x 1-3/4" bolts, 1/4" lock washers and 1/4" flat washers and tighten until the lower mounting bracket secures the console safe to the bottom of the factory console well. Remove any plastic shavings and install the supplied carpet insert into the bottom of the safe.

14. Place the factory console tray into the opening as shown. Reverse the disassembly procedure to finish the installation. **Prototype combination lock shown. Production combination locks are silver.**
For the owner: Follow the supplied detailed instructions on the following page and choose your lock combination.
