# **2003-07 Ford 6.0L Boost Builder**

**P/N# 1516000**

**- Installation Manual -**

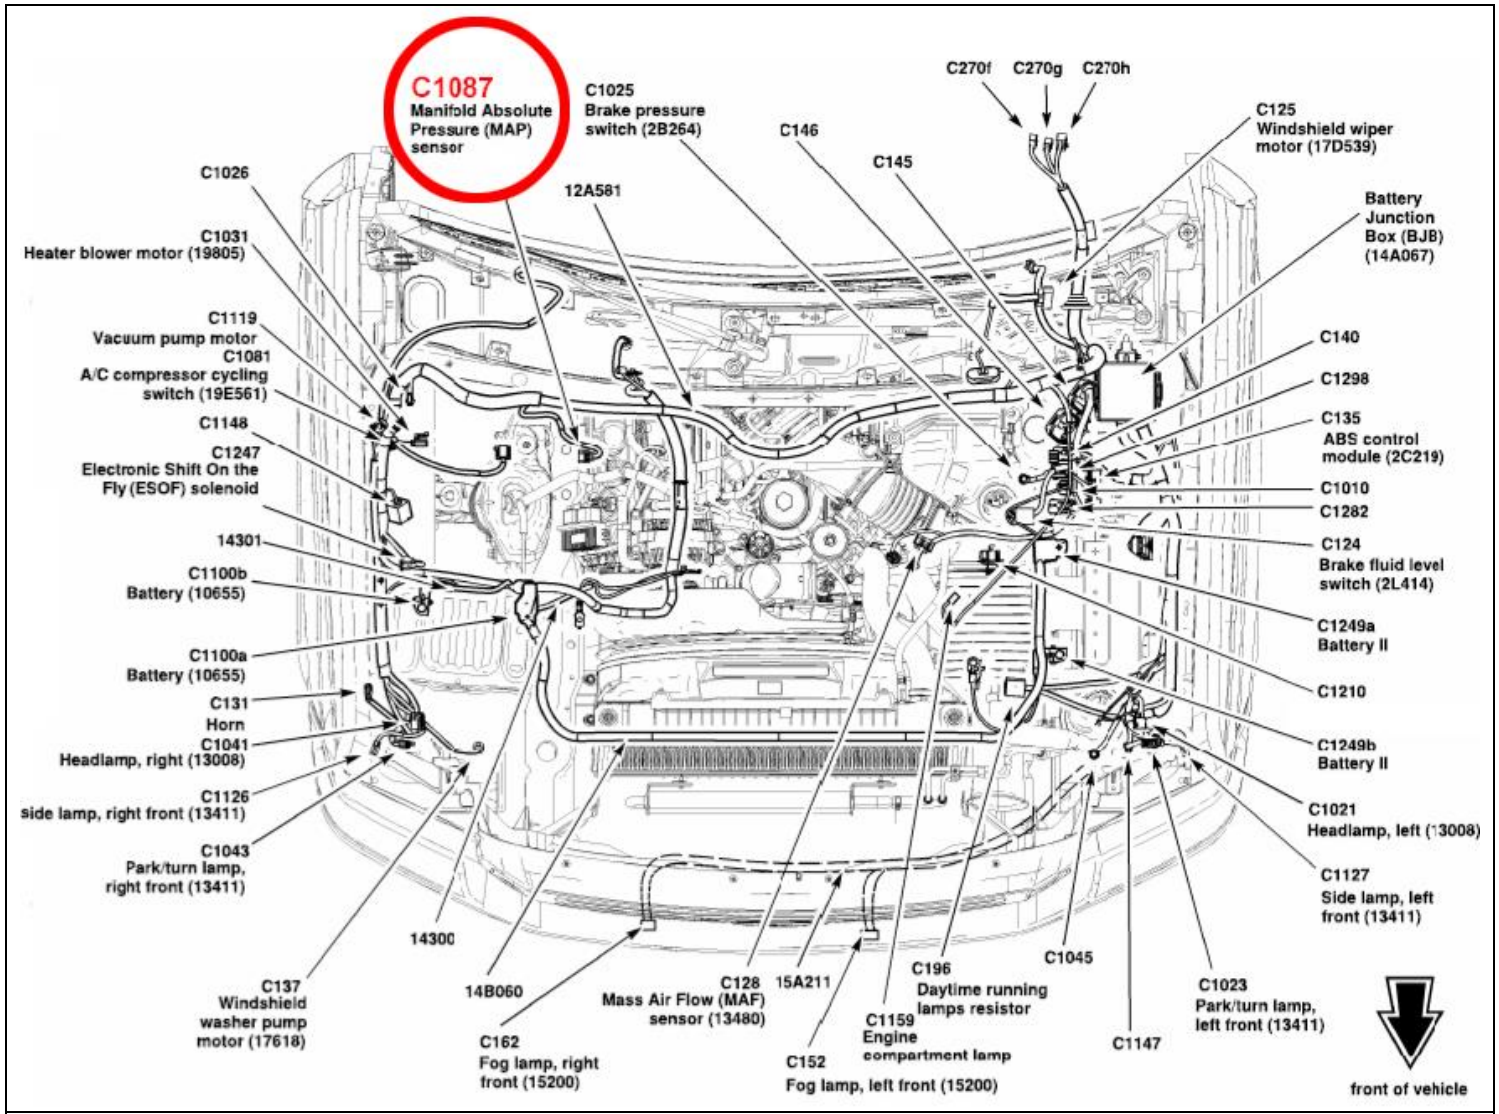
Locate the factory MAP sensor on the passenger side of the vehicle. It should be mounted near the firewall on a pedestal.

Remove the connector from the sensor and plug in the mating connector on the BD boost builder to the sensor. Also plug the other side of the connector to the factory connector.

Note that this factory connection is sometimes very difficult to separate. There is a red locking pin on the top that needs to be removed first.
