INSTALLATION INSTRUCTIONS

Muffler Delete Exhaust

MAKE: GM
MODEL: Silverado
YEAR: 2019
ENGINE: V8-6.2L

49C44114NM

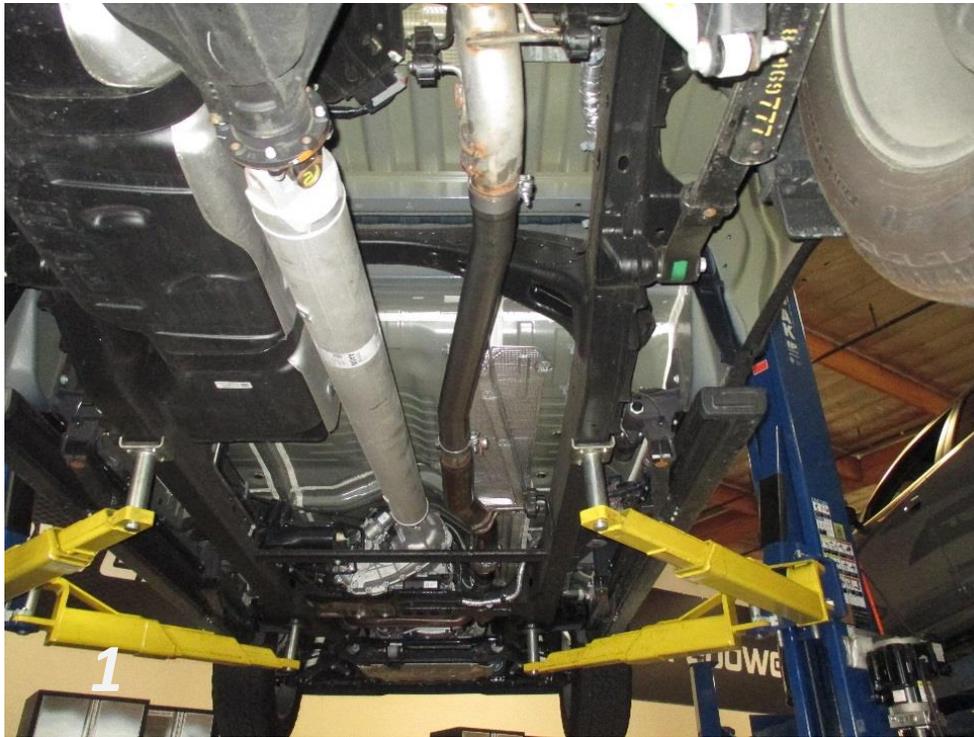
4. Secure the stock exhaust with jack/stands.
5. This system will require cutting of the O.E Exhaust.
6. Using a marker, scribe a line at the front of the muffler as close as you can to the muffler as shown in the image below.

7. Scribe a second line directly behind the rear valve as shown in the image below.
8. Cut exhaust system at both lines and remove the O.E. muffler.
9. Now remove the back half of the O.E exhaust.
